Review of Long-Term Maintenance Plans for the South Jetty, Grays Harbor, Washington

Final report

Prepared for U.S. Army Engineer District, Seattle
Seattle, WA 98124-2255

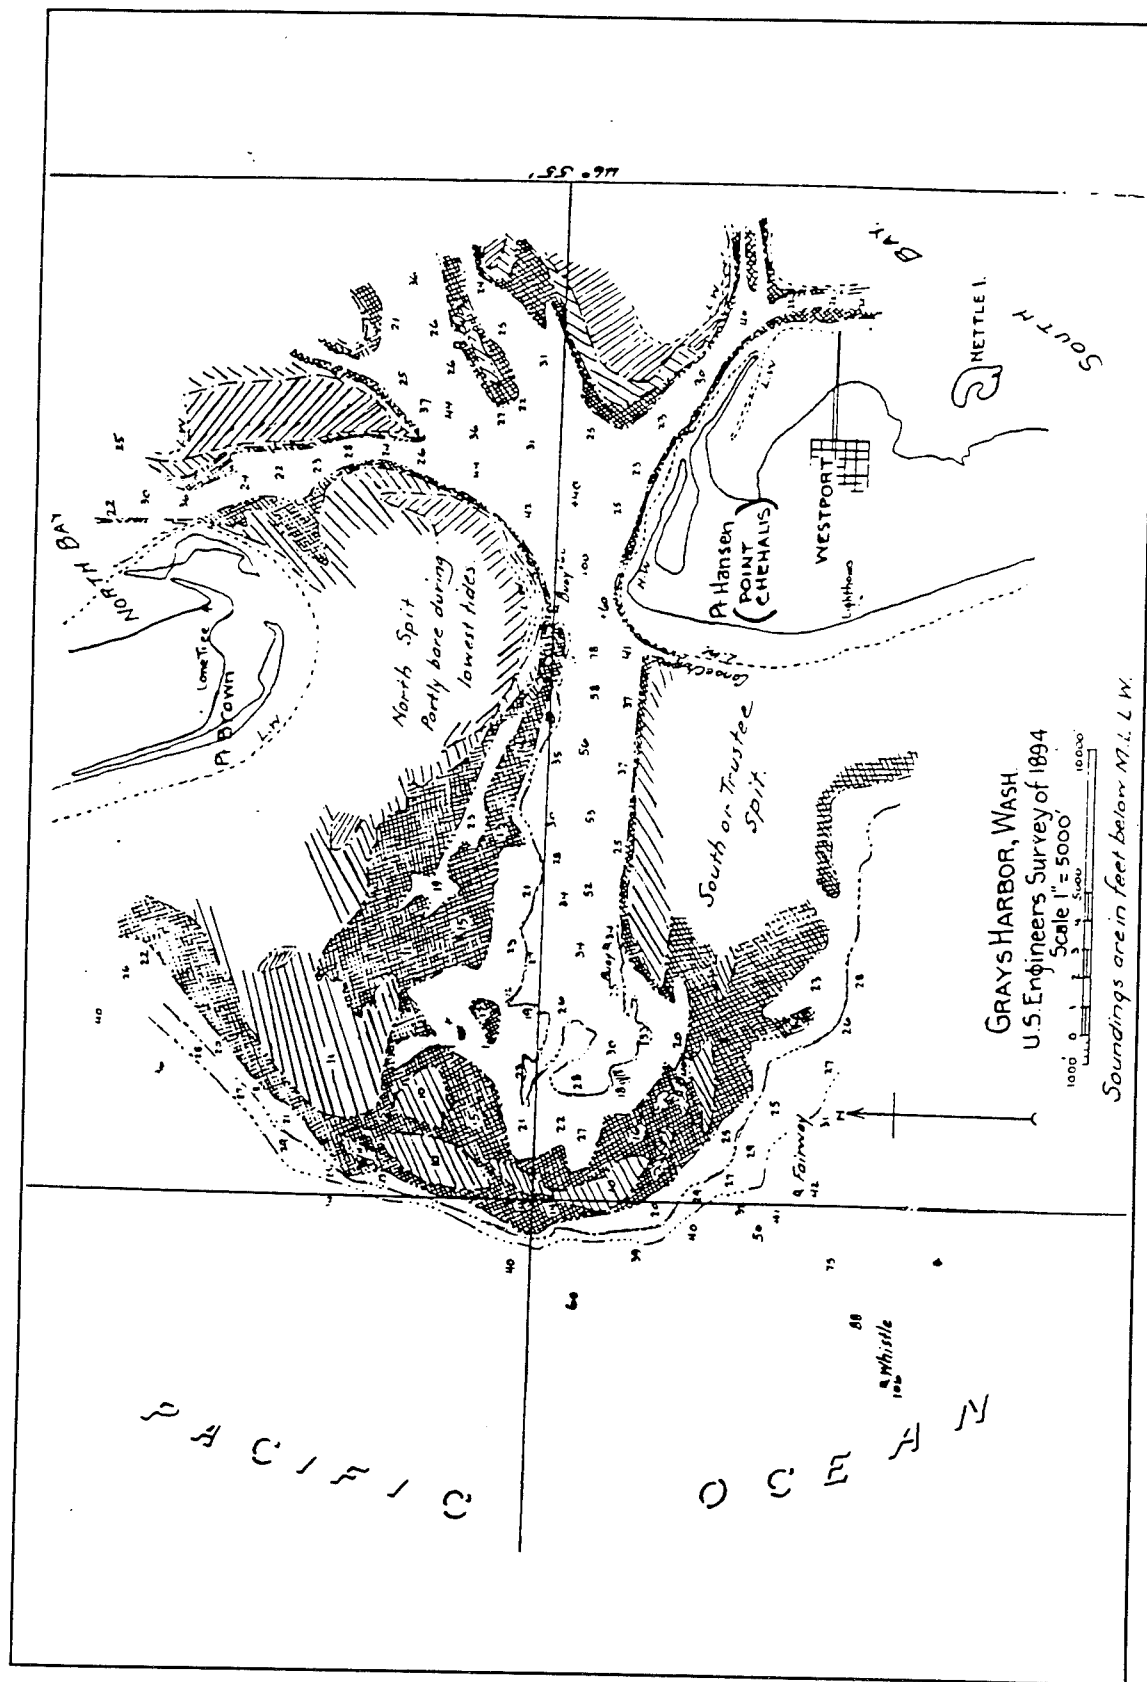
Figure 2. Entrance configuration before jetty construction

9. The configuration of the entrance in 1894, prior to construction of jetties, is presented in Figure 2. A deep entrance channel is shown in the figure. This channel was maintained by strong ebb currents resulting from constriction of tidal flows by sand encroaching from both north and south. An outer bar and deposits inside the entrance formed where ebbing and flooding tidal current velocities slowed. This figure is a "snap-shot" of a very dynamic natural entrance that changed its configuration with changing wind, wave, and sediment supplies. Shifting sands and shallow water at the outer bar created severe hazards to navigation, including grounding of ships and steepened wave conditions. Construction of jetties to stabilize the position of the entrance channel, to provide a protected entrance, and to create eroding currents at the outer bar began in 1898 and were completed in 1916. Alignments of the jetties are shown in Figure 3.

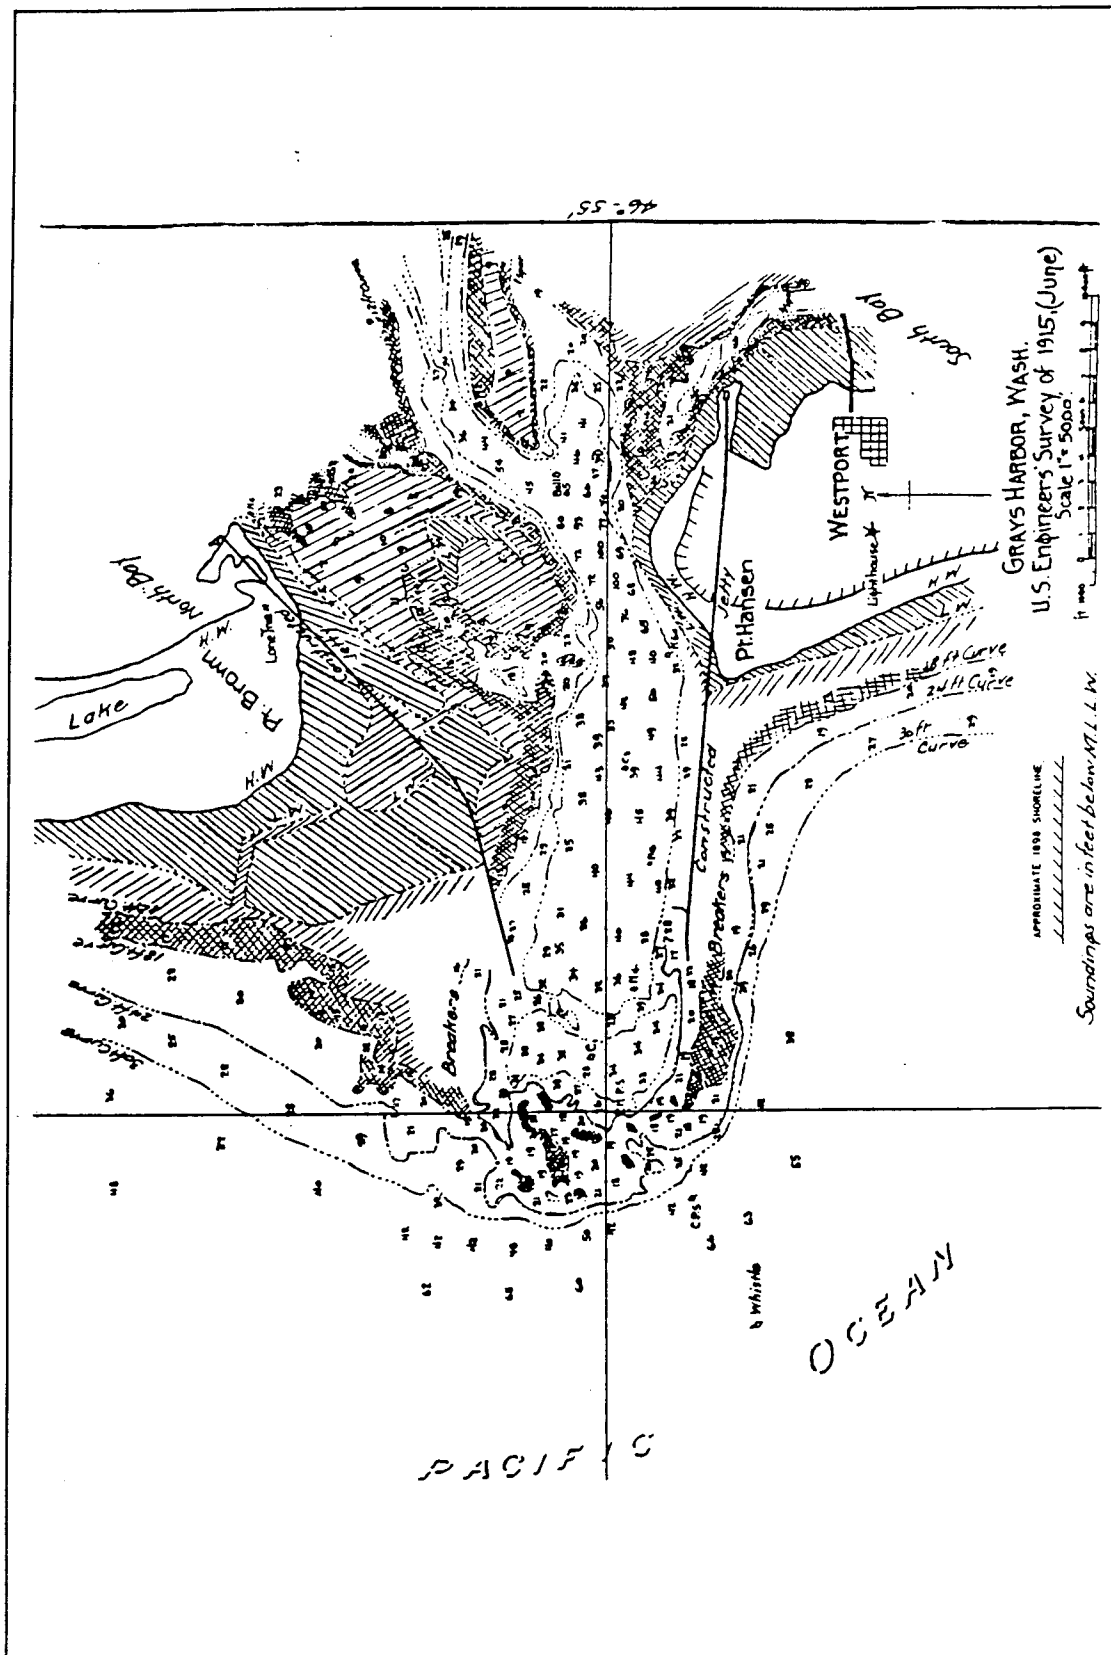
Figure 3. Entrance configuration on completion of jetties

15. Figure 3 shows the configuration of the entrance in 1915, the time when the jetties were nearly completed. The entrance channel is broader than the channel was prior to construction, shown in Figure 2, and has about the same depth. It emerges near the center of the outer ends of the jetties. Material had been scoured from the entrance and deposited on the outer bar. Sand was deposited along the south side of the south jetty (then 13 years old).

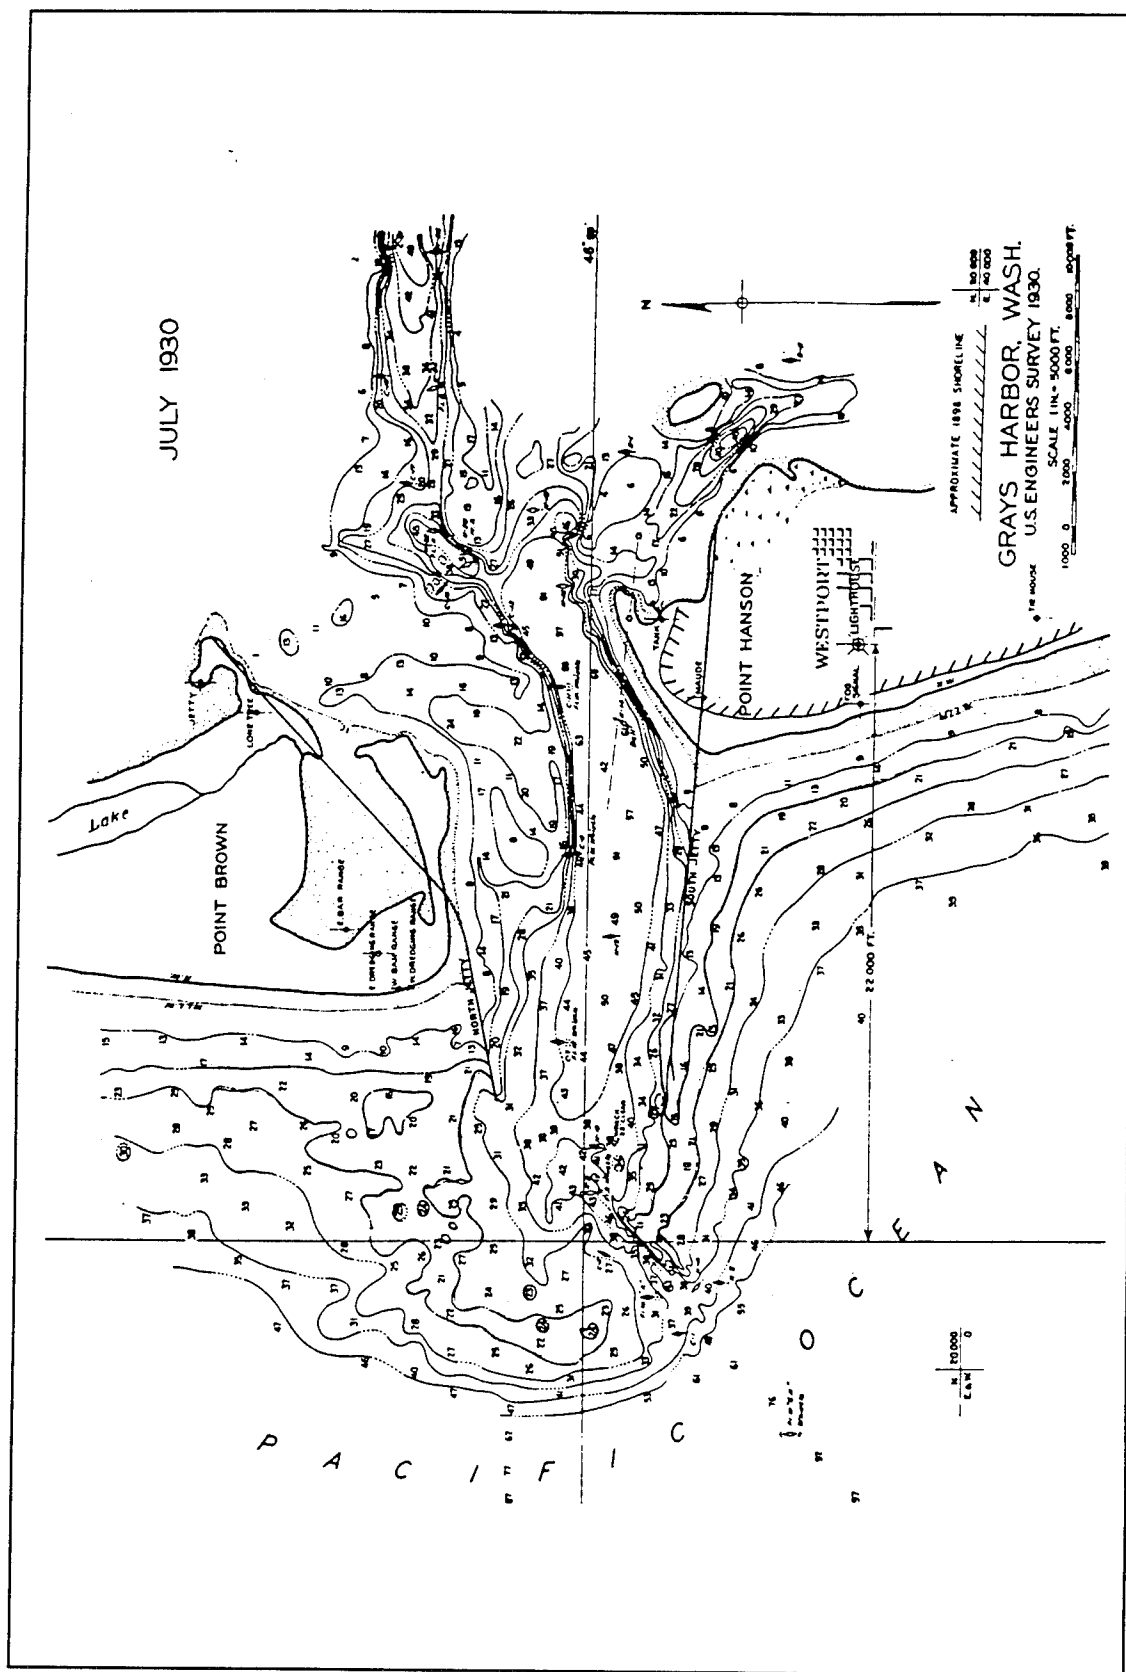
Figure 4. Entrance configuration in 1930

16. Figure 4 shows the configuration of the entrance in 1930. Comparison with Figure 3 shows that the entrance channel is deeper but narrower, and the north side of the entrance channel has moved south. Depths of water over the outer bar were greater, and Point Brown extended further south and west. The west shore of Point Hanson (South Beach) was eroded.

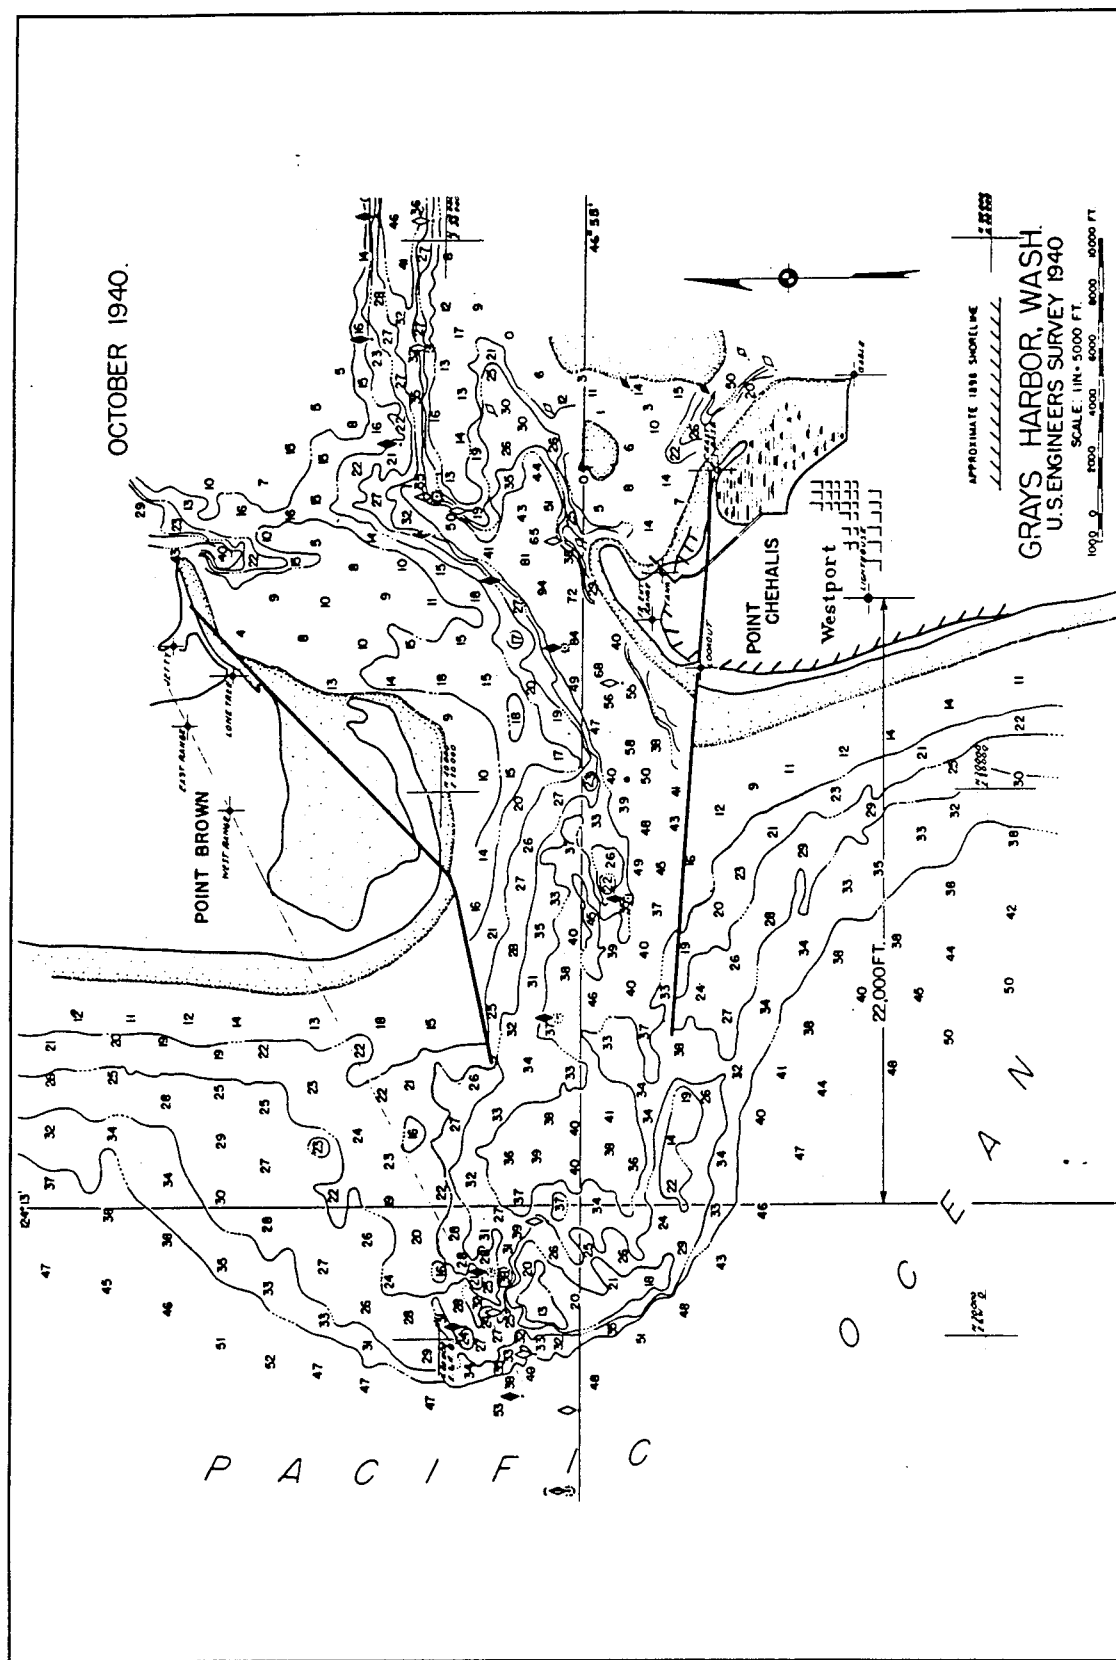
Figure 5. Entrance configuration in 1940

17. Figure 5, showing the configuration of the entrance in 1940, indicates a continuation of the trends described above. The entrance channel was hard against the south jetty and still narrower than it was in 1930. The inner bar deposit south of the north jetty, across the jetty from Point Brown, has accumulated more sediment, as had the deposit at the north tip of Point Hanson -- now Point Chehalis. South Beach was eroded further.

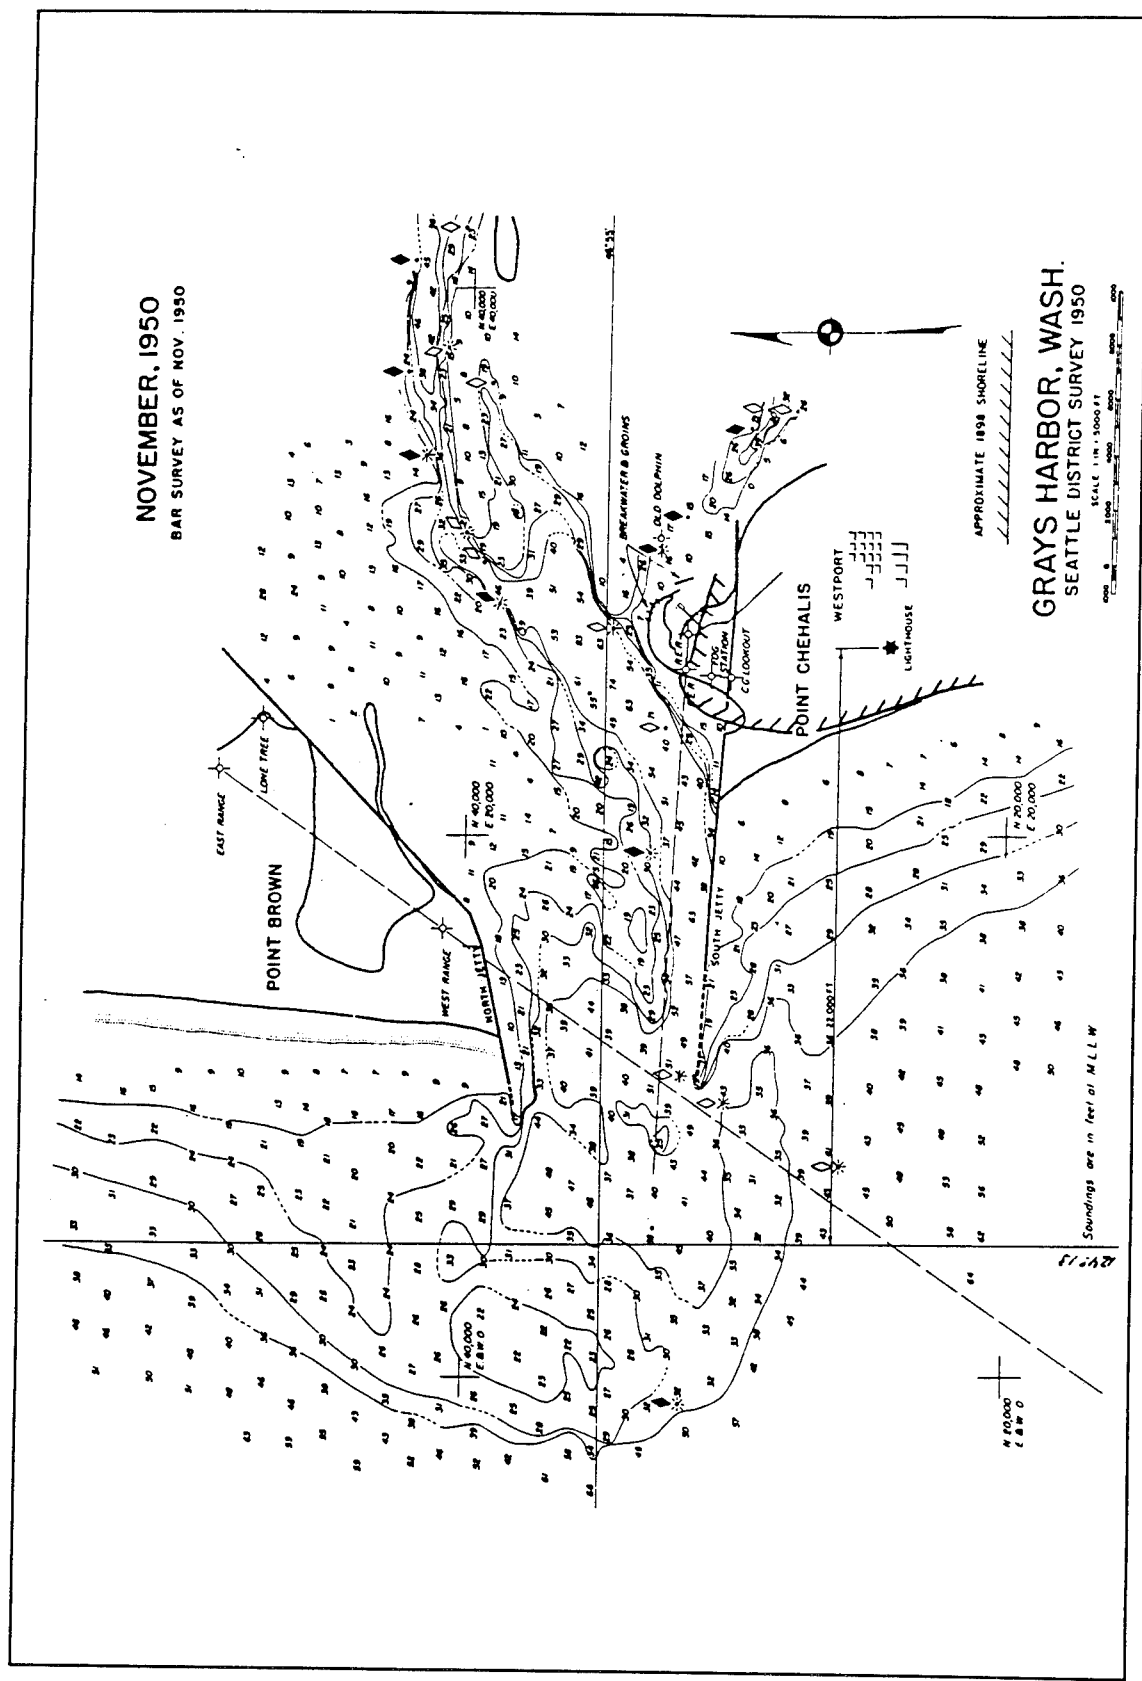
Figure 6. Entrance configuration in 1950

18. Figure 6, dated 1950, shows continuing evolution as described above. The entrance channel was still narrower and deeper, the inner bar deposit north of the channel had accumulated more sediment, and North Beach on Point Brown had advanced toward the outer end of the north jetty. It appears that there was some deposition at the north end of South Beach. This plot shows the first indication of erosion at the east end of the south jetty and of the Point Chehalis shoreline.

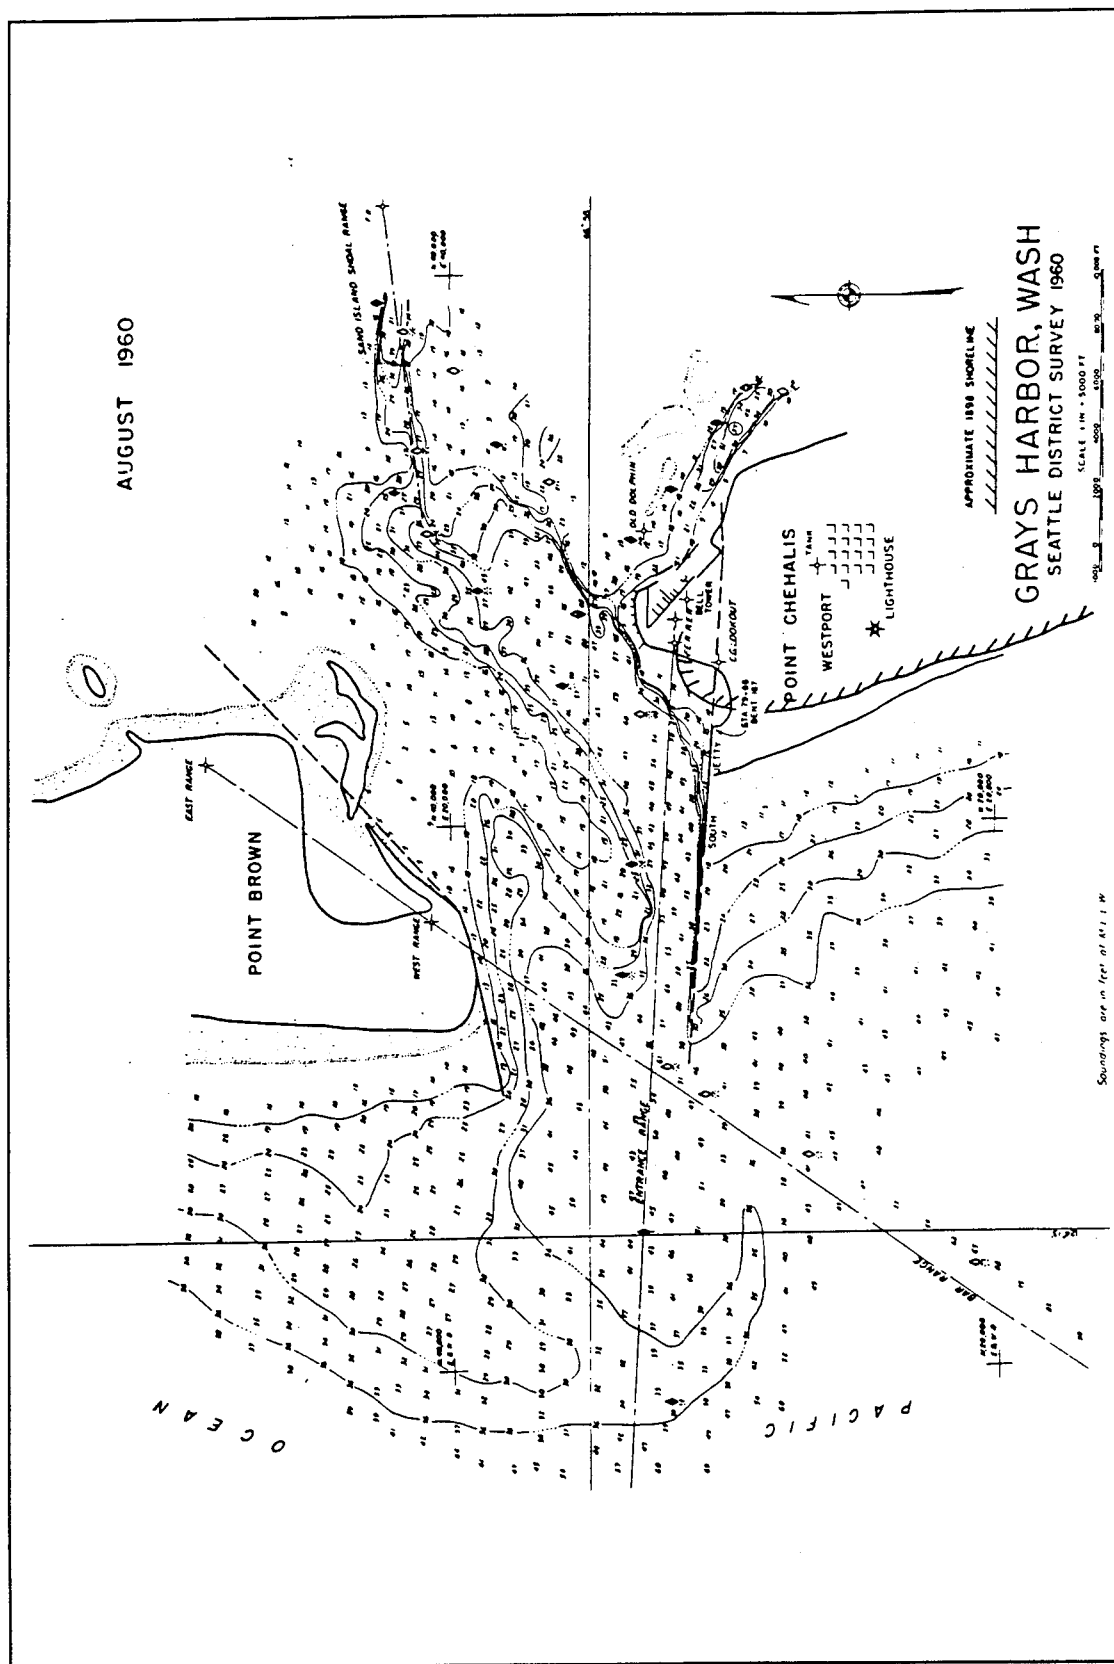
Figure 7. Entrance configuration in 1960

19. Figure 7, dated 1960, when compared with Figure 6, shows erosion of the outer bar and widening of the entrance channel. There was slight erosion of North Beach and some deposition on South Beach. Erosion at the east end of the south jetty had progressed, forming Half Moon Bay. Further erosion of the Point Chehalis shoreline had occurred.

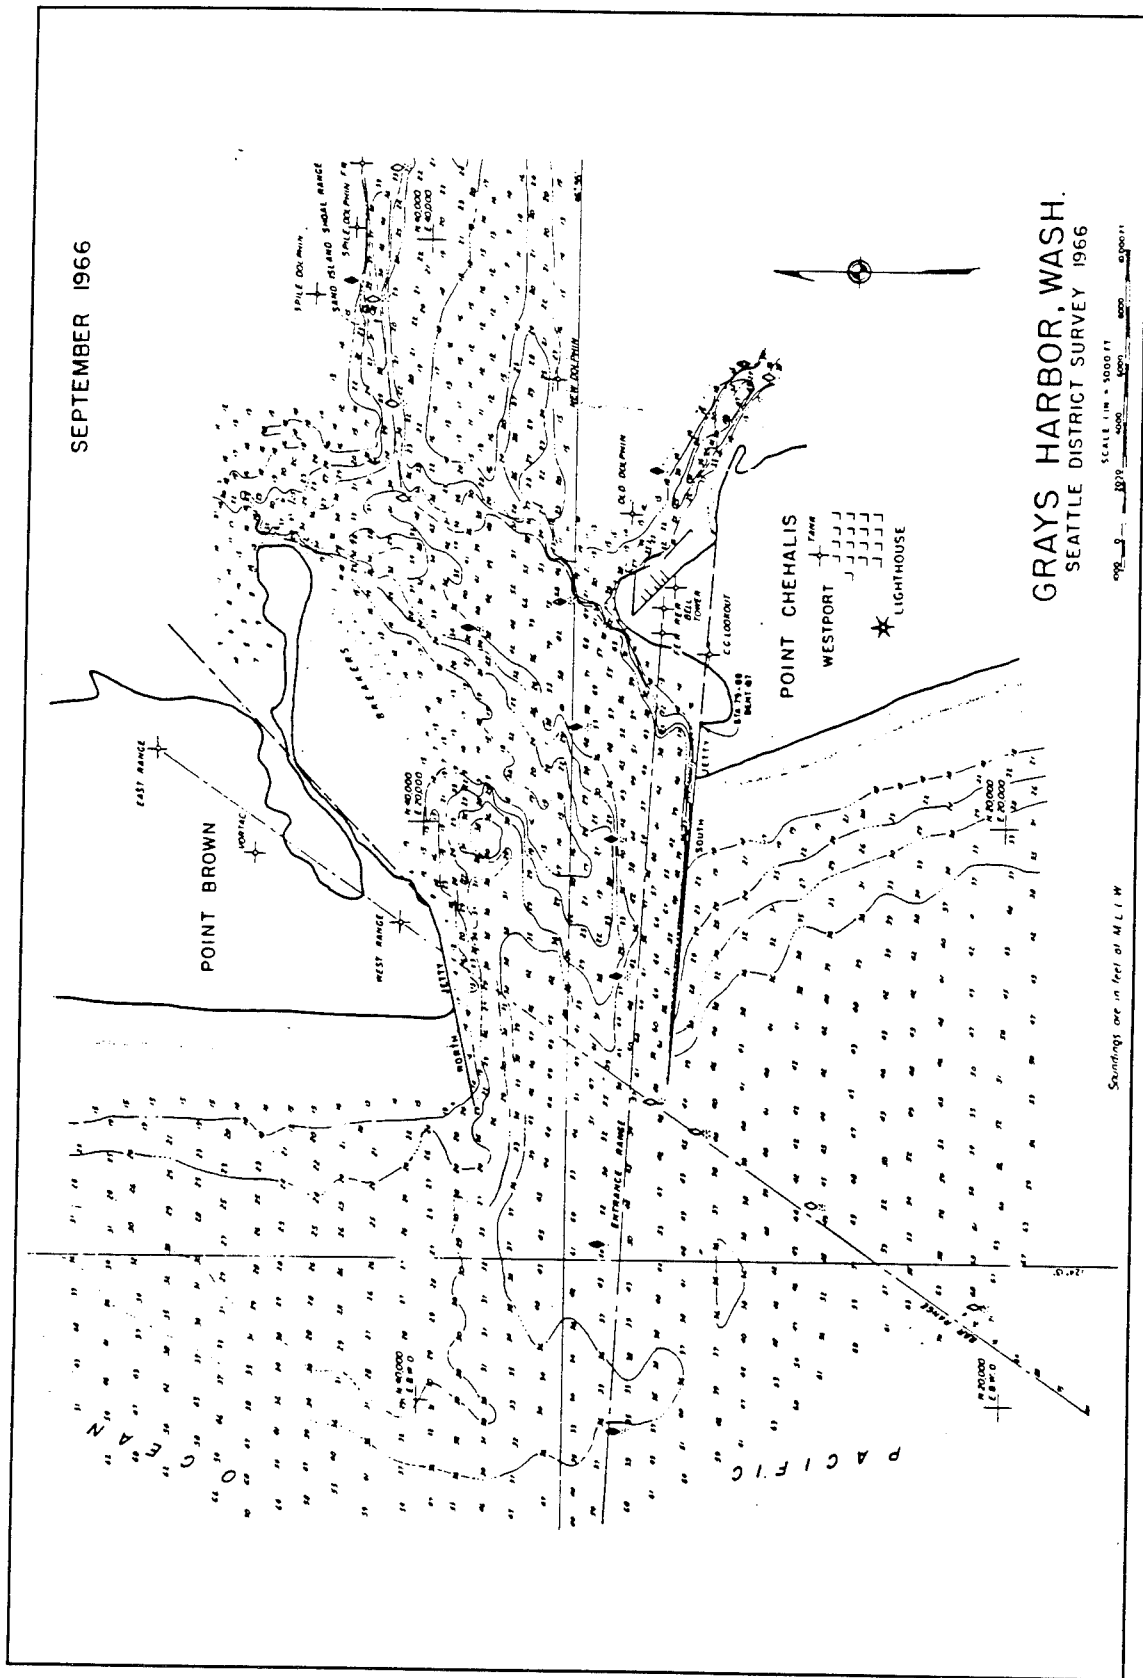
Figure 8. Entrance configuration in 1966

20. Figure 8, dated 1966, when compared with Figure 7, shows additional deposition on the inner bar deposit south of the north jetty and some erosion of the east shore of Half Moon Bay. There was further erosion of the outer bar.

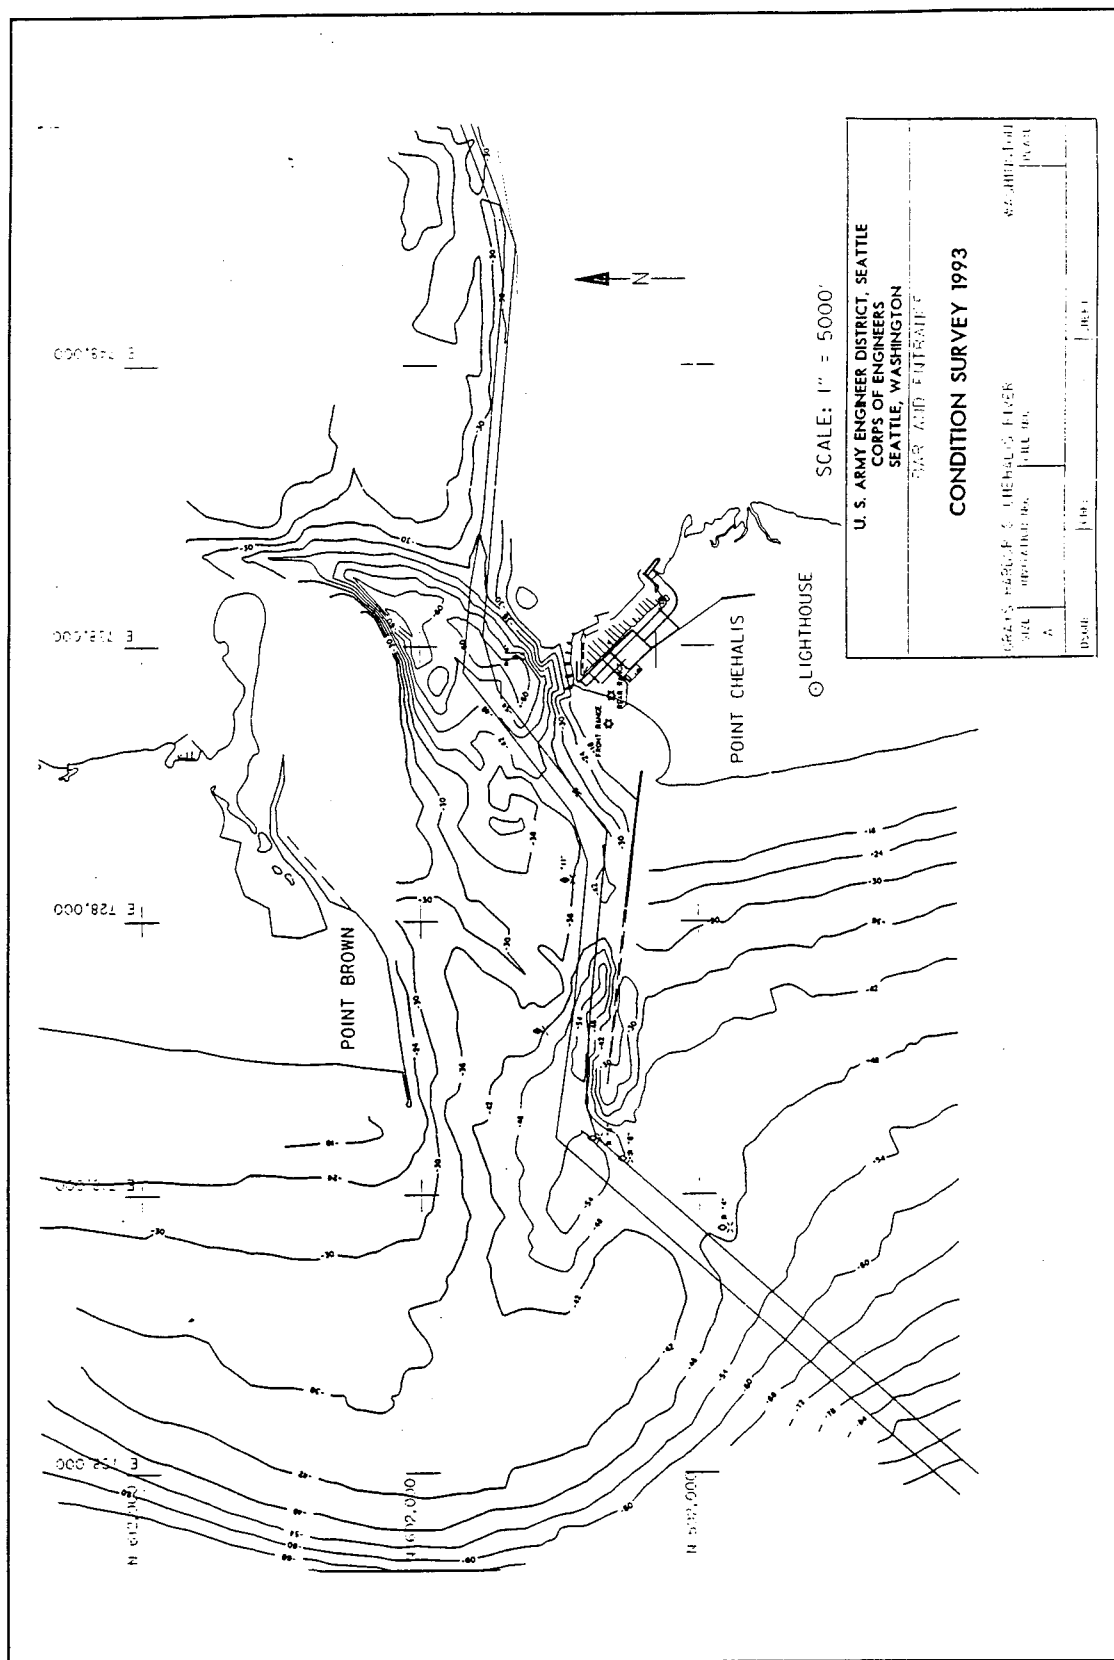
Figure 9. Entrance configuration in 1993

21. Figure 9 shows the December, 1993 configuration of the entrance including the recent breach at the east end of the south jetty. The trends

shown in the previous figures continued. South Beach was eroded, Half Moon Bay was enlarged, and North Beach was filled westward nearly to the outer end of the north jetty. The shallowest contour on the outer bar is -42 ft (the contour interval is 6 ft).

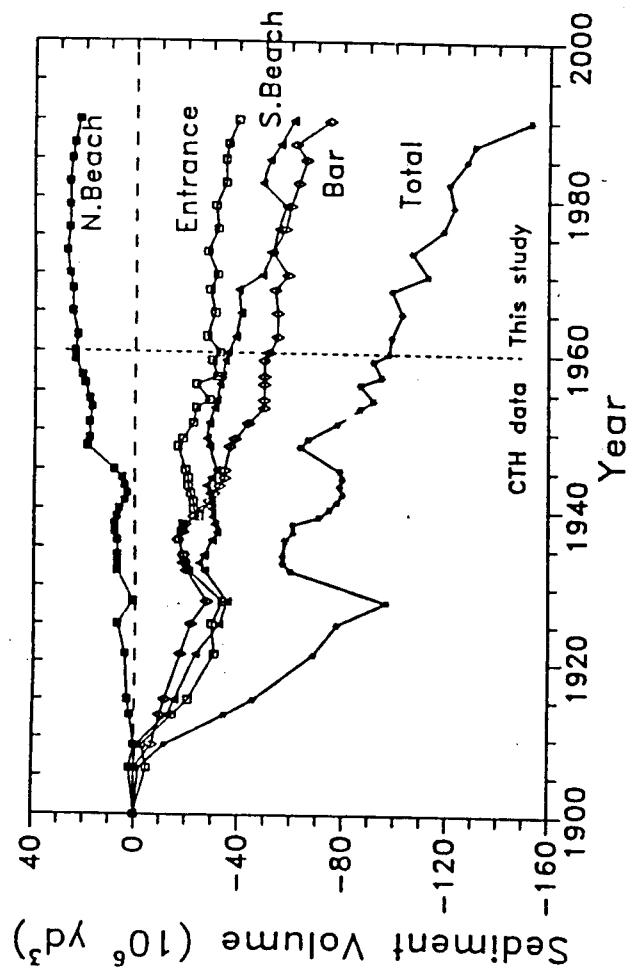
Figure 13. Historic volume changes for selected areas (from Battelle/Marine Sciences Laboratory 1992)

38. The plot of total volumes in Figure 13 shows continuing loss of sand from the region over a period of ninety years. This period is too long to attribute the loss to cyclic causes, such as variability of winter weather. It is most likely a result of the impacts of the jetties on the areas included in the computation. The jetties first caused erosion of sand from the entrance and its deposition on the bar, where it was subsequently eroded by waves and coastal currents. Sand that entered the entrance from North Beach crowded the entrance channel until velocities were sufficient to carry additional sand seaward or landward beyond the areas included in the calculation. Waves in the entrance must also have contributed to movement of sand. And finally, South Beach was deprived of a sand supply and subjected to erosion as described in paragraph 31.

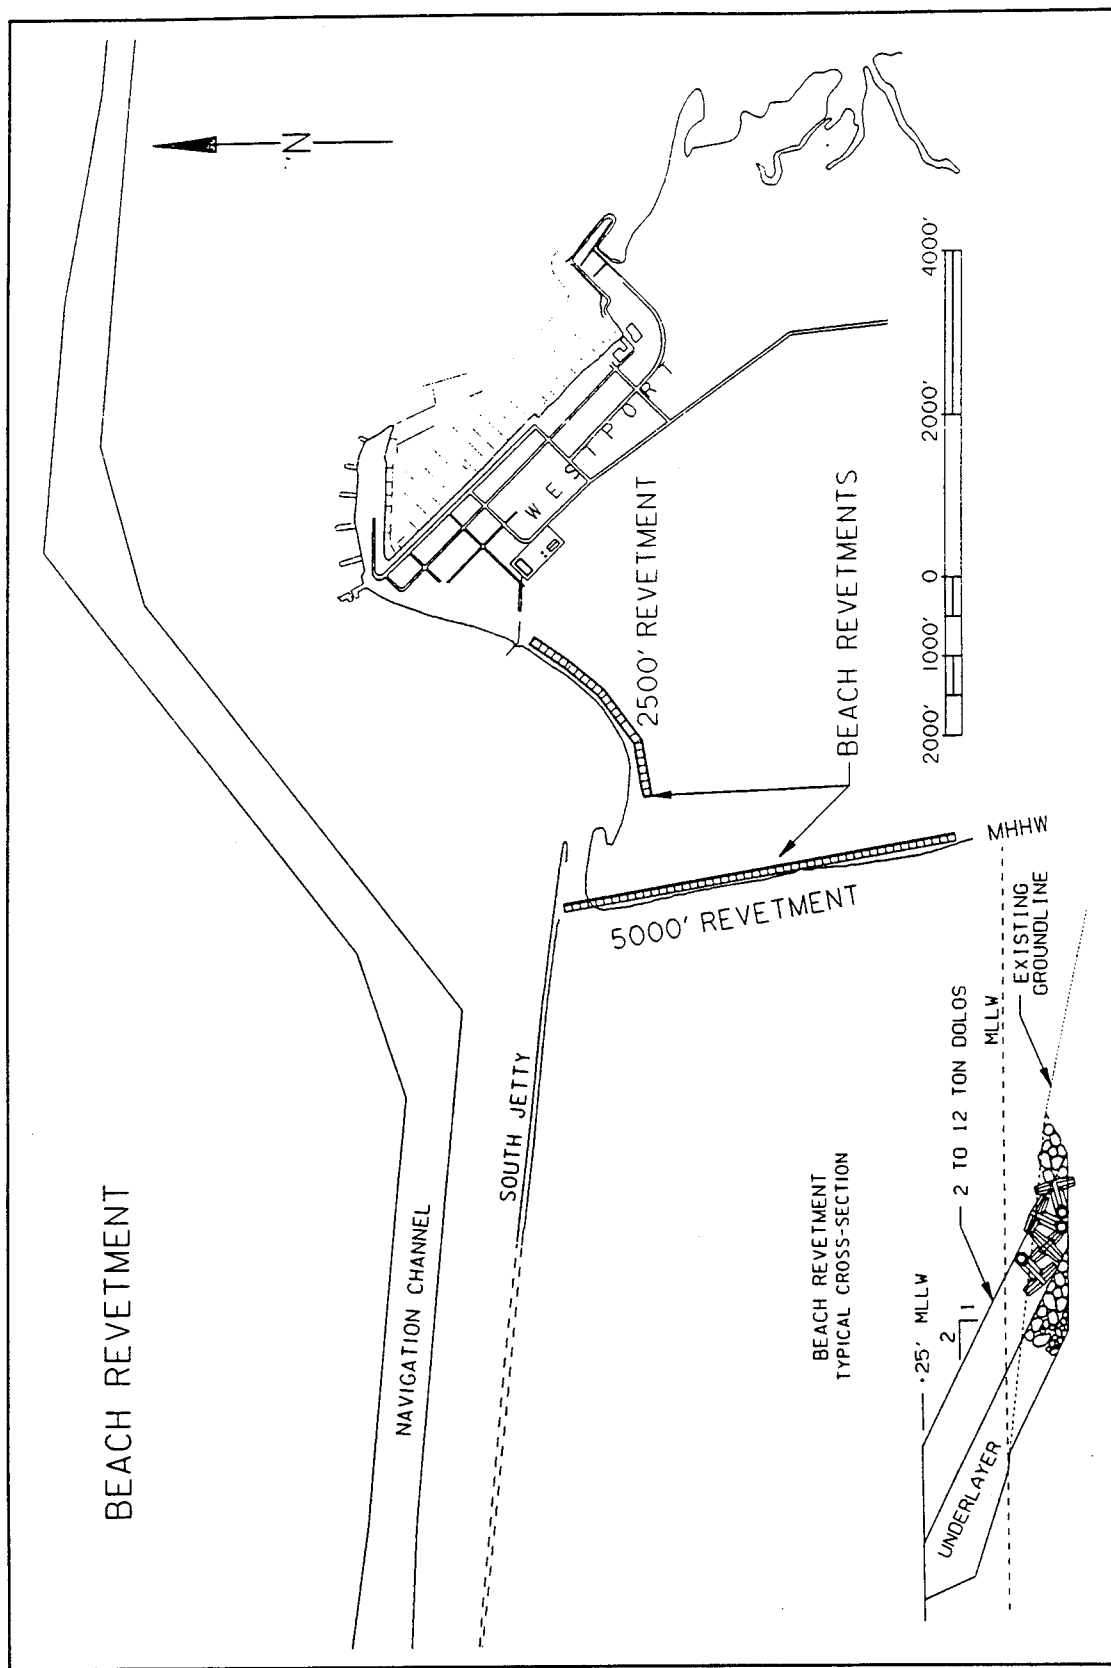
Figure 15. Beach revetment alternative

46. This alternative is shown in Figure 15. It includes revetment along South Beach and extension of the revetment in Half Moon Bay. In addition to a very high initial cost, erosion of sand at the base of the revetment down South Beach would cause continuing requirements for expensive maintenance.

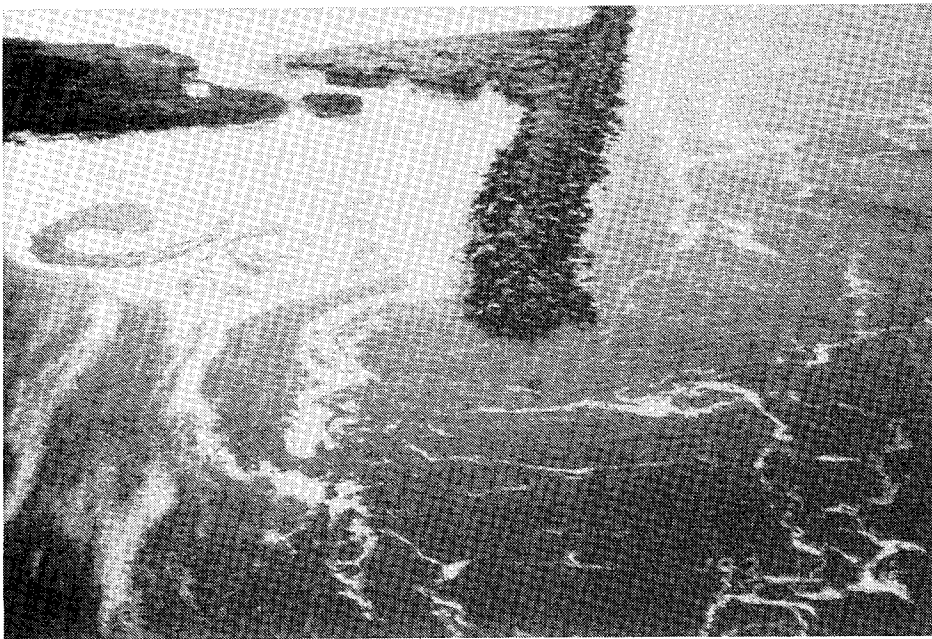
Photo 1. Initial breach formation, looking seaward, 10 December 1993

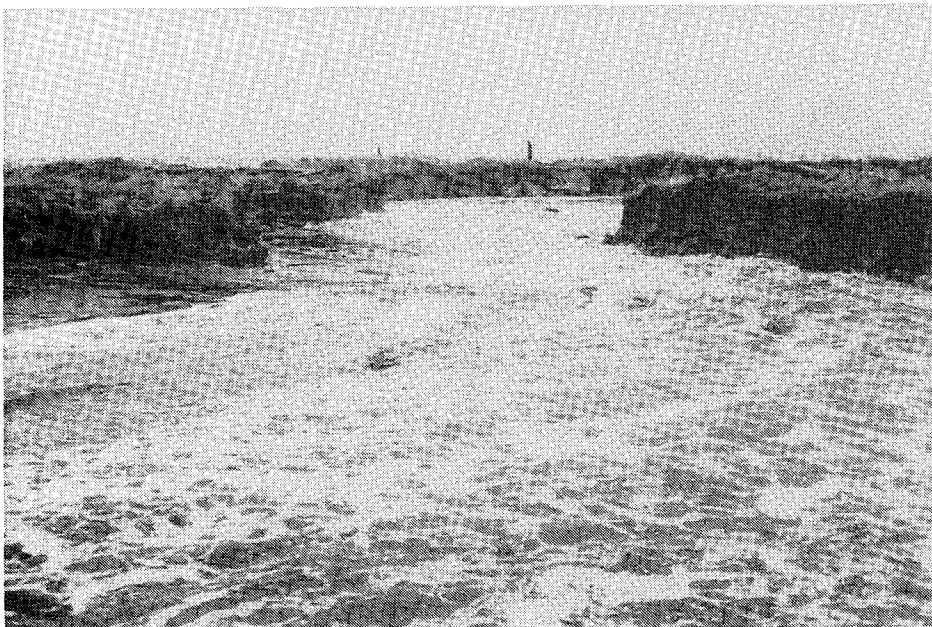
Photo 2. Initial breach formation, looking landward, 10 December 1993
